UNDERWATER BRIDGE INSPECTION REPORT

STRUCTURE NO. L8159

MISSISSIPPI RIVER OVERFLOW

DISTRICT 9 - WASHINGTON COUNTY, CITY OF COTTAGE GROVE

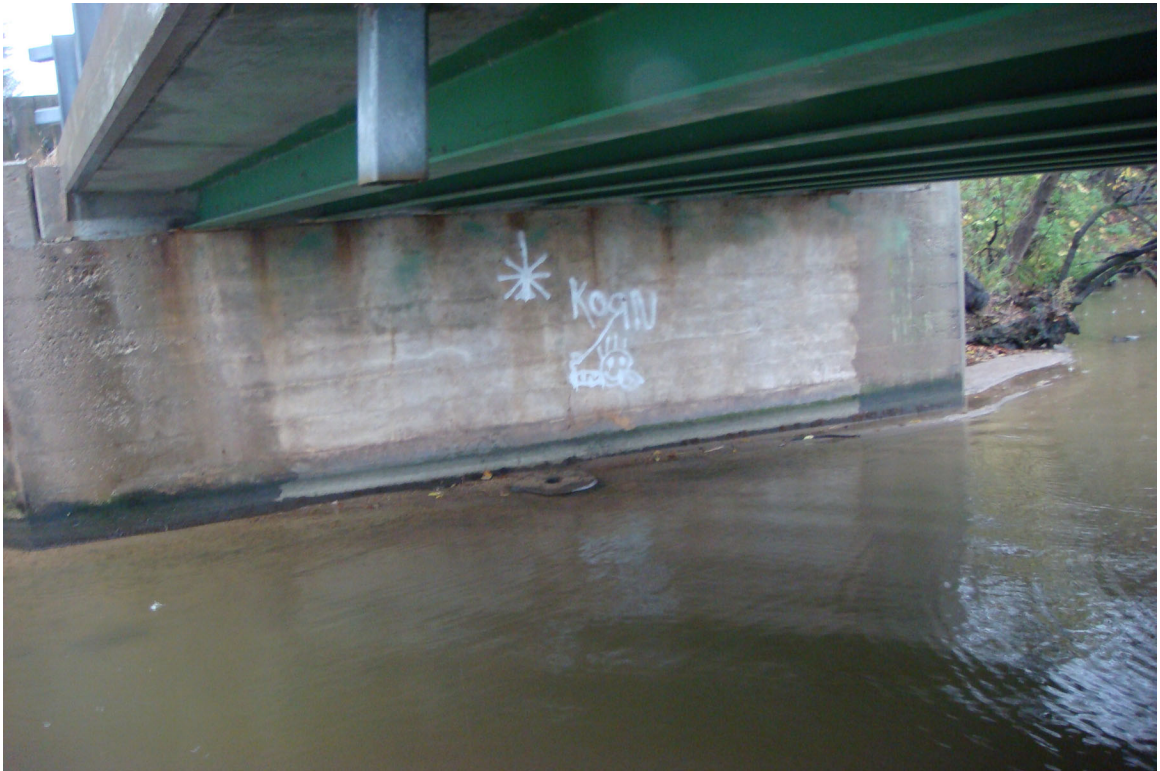
Photograph 1. View of West Abutment, Looking West.

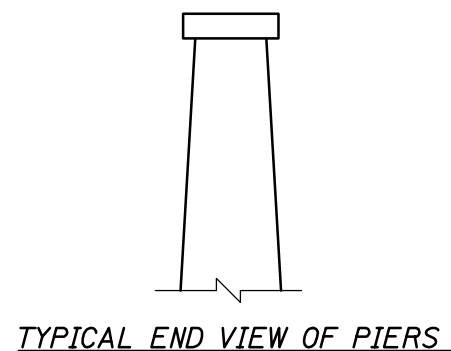
SOUNDING PLAN

- 1 Three evenly spaced vertical hairline cracks were observed at the center of the East Abutment from the top of the abutment to 1 foot above the waterline.

- 4 A 6-inch-wide band of minor scaling was observed at the waterline at Piers 1 and 2.
- 5 An area of section loss, 3 inches in diameter, was observed 6 inches above the channel bottom on the upstream end of Pier 2 with up to 1 inch of penetration.

- 6 Two areas of section loss, 6 inches in height and 12 inches wide, were observed 4 feet below the waterline with up to 1 inch of penetration.
- 7 An area of section loss, 6 inches in diameter, was observed on the corner at the channel bottom with up to 2 inches of penetration.

- 8 An area of section loss, 8 inches in diameter, was observed at the waterline with 1.5 inches of penetration.
- 9 The channel bottom consisted of sand, riprap, and broken concrete with no appreciable probe rod penetration.
